ROAD TRANSPORT
COMPANY

G-FENCE 600Z

SILUR FX

SO-BEAM

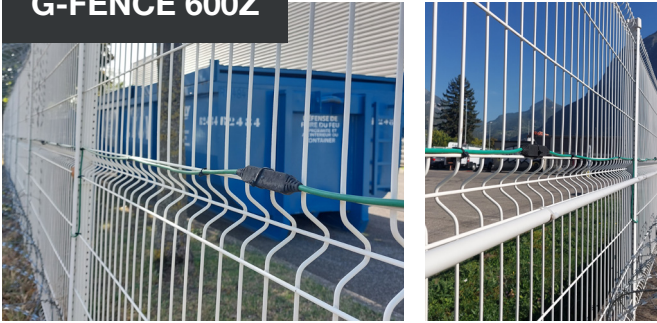
Deployed over 400 meters of fencing, G-FENCE 600Z analyzes vibrations to trigger an alarm based on selected sensitivity, the number of impacts on the fence, etc. Its zoning function allows precise localization of any attempt at cutting, tearing, climbing, or crossing.

400m

of G-FENCE 600Z

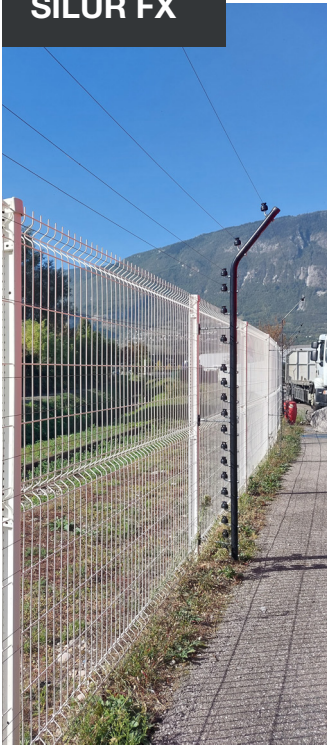
The SILUR system primarily serves as a deterrent, which has already proven effective since its installation on-site. Our experts also adapted the electrification solution to the site's layout (rear area) and the type of fence to ensure optimal security.

300m

of SILUR FX

2.40 m high - 19 wires

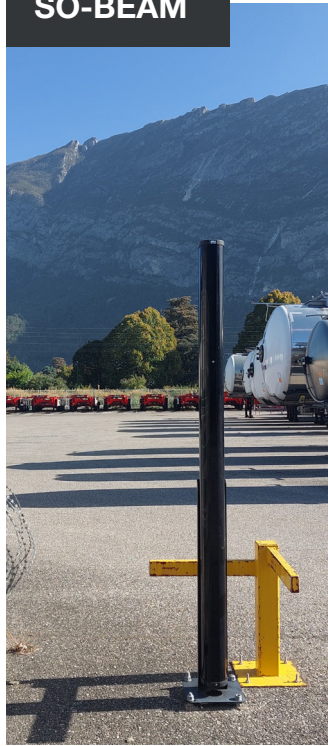
Installed at the two gates to quickly enhance intrusion detection with a no-civil-works solution, ensuring complete perimeter security.

2

SO-BEAM

2m high, to secure
the 2 gates
